Manhole Inspection Summary

Manhole # S31I__021MH

Insp Date: **12/19/08 9:41 AM**

Location Address: **22 W Lombard st**

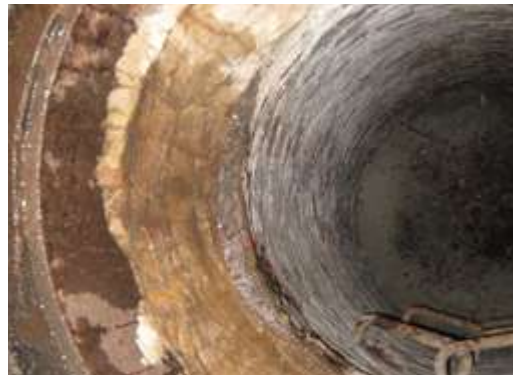
Defect 6

Condition: ☐ Sound ☐ Cracked ☒ **Leaks**

Infiltration: ☐ None ☒ **Joint** ☐ Cracks ☐ Mortar ☐ Roots ☐ Wall

lid/frame and chimney infiltration

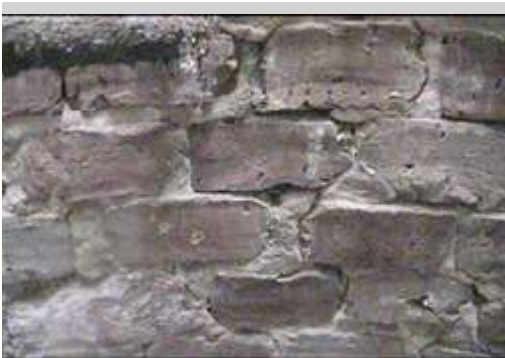
Defect 4

Condition: ☐ Sound ☒ **Cracked** ☐ Root Intrusion ☐ Loose Brick ☒ **Deteriorated**

deterioration in corbel

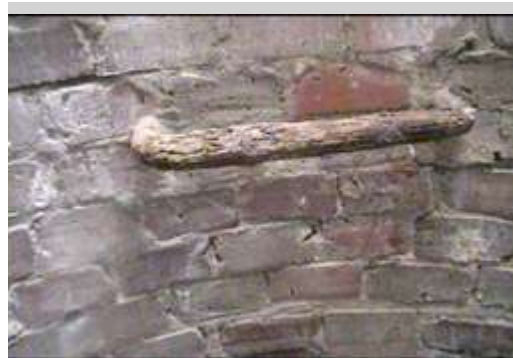
Defect 3

Count: **6** Missing: **0** ☒ **Corroded**

corroded rung

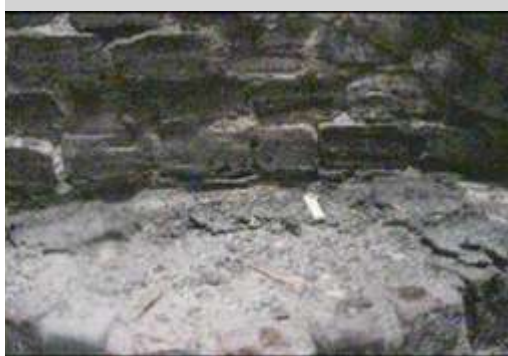
Defect 2

Condition: ☐ Sound ☐ Cracked ☐ Root Intrusion ☐ Deteriorated ☐ Leaks ☒ **Debris**

debris on bench

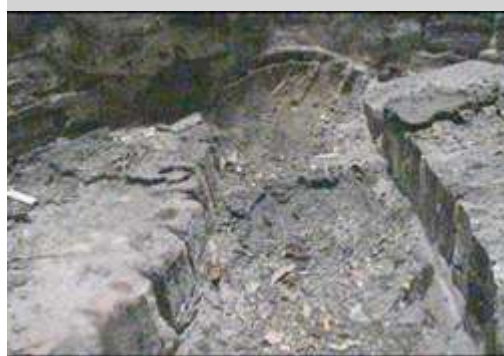
Defect 1

Condition: ☐ Sound ☐ Cracked ☐ Root Intrusion ☐ Deteriorated ☐ Leaks ☒ **Debris**

debris in channel

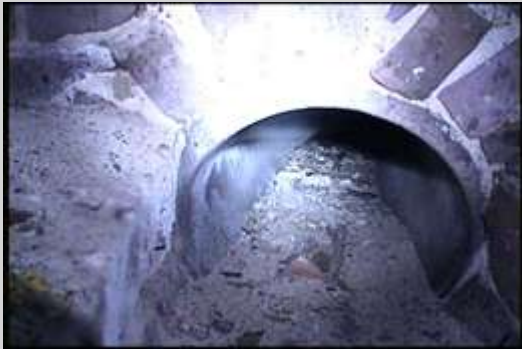
12 O'Clock Outflow

Deposits: ☐ None ☒ **Mud** ☐ Sludge ☐ Debris ☐ Grease

Silt Depth: **1** (in.) Deposits Extent: **Light**
